#### UNITED STATES DISTRICT COURT WESTERN DISTRICT OF TEXAS AUSTIN DIVISION

JON R. DEUTSCH	§	
	§	CIVIL ACTION NO. 1:16-CV-371
Plaintiff	§	
	§	
VS.	§	
	§	
NEMEROW INVESTMENTS LLC	§	
	§	
Defendant	§

#### **COMPLAINT**

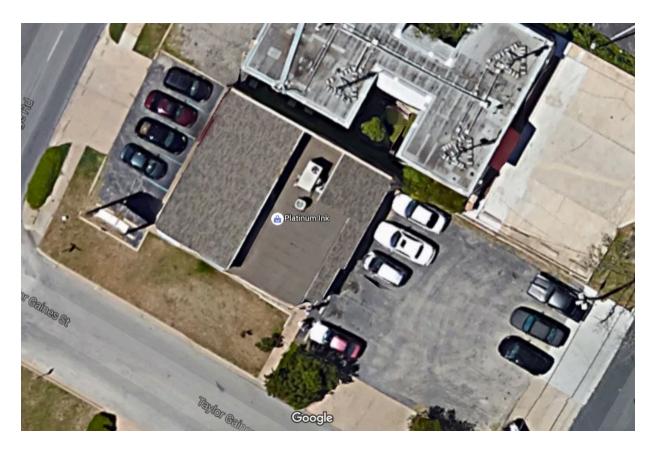
Fig. 1 - Overhead view of PLATINUM INK IN 2015.

Satellite Images from *Texas General Land Office, Texas Orthoimagery Program, U.S. Geological Survey, 2015.* Note: This property has zero ADA-Compliant Disabled Parking Spaces near the business entrance. Under the Americans with Disabilities Act, this business must have 1 ADA-Compliant Van Accessible Parking space (96" Wide with 96" Side Access Aisle) near the business entrance.
